# Structural Assessment Report

Two-storey residence (specimen) — Dumaguete City, Negros Oriental

| Report reference | AEDO-SA-SPECIMEN-01 |
| Purpose of assessment | Evaluate reported diagonal cracking above a ground-floor window and report on the overall structural condition |

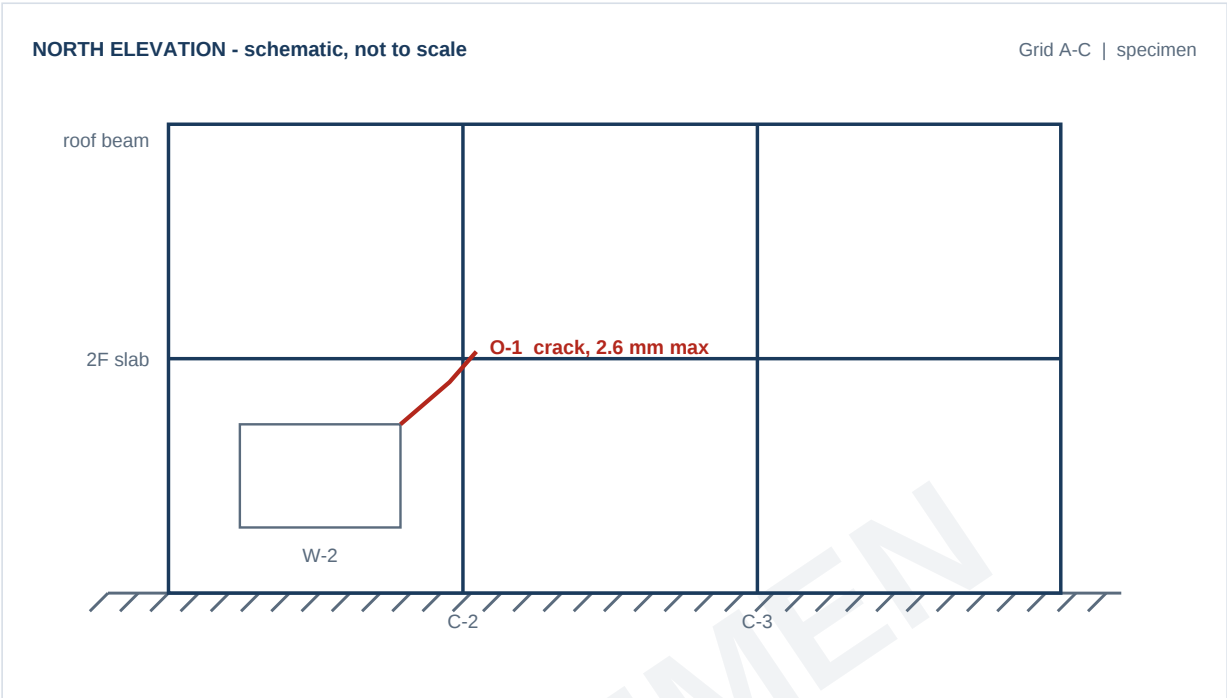
Appendix A — Crack location sketch

| Ref | Location / member | Observation | Measured |
|---|---|---|---|
| O-1 | Ground floor, north elevation, infill wall panel above window W-2, grid A-B | Diagonal crack from the upper window corner running toward the beam soffit, visible on both faces of the wall, following the mortar joints in part and passing through blocks elsewhere | 2.6 mm at widest, 1.4 m long |

The crack at O-1 originates at the upper corner of window W-2, which is the stress concentration point in an infill panel and the location where in-plane movement, thermal movement and shrinkage all concentrate. Its width and the owner's account of progression place it beyond shrinkage. Because the panel is infill rather than load-bearing, the condition is a serviceability and durability matter, not a loss of frame capacity. It does, however, record that movement has occurred, which is why Section 9 sets a monitoring plan rather than a repair instruction.

Schematic elevation, not to scale. Prepared from measurements taken on site; no architectural drawing was available. Specimen.

| Priority | Action | Refers to |
|---|---|---|
| Within 3 months | Implement the monitoring plan in Section 9 for the O-1 crack. Do not fill or plaster over the crack before the monitoring period ends, as that destroys the evidence. | F-1 |

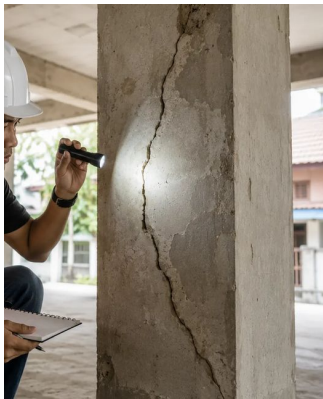
| Ref | Finding | Severity | Action |
|---|---|---|---|
| F-1 | Diagonal cracking in a non-load-bearing infill panel above W-2, consistent with movement rather than shrinkage. No effect on frame capacity | S2 | Monitor |

**Photo 1** — O-1, diagonal crack above window W-2, north elevation, ground floor. Comparator card in frame. Illustrative photograph.

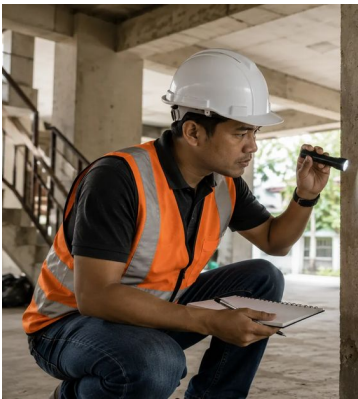
| Ref | Location / member | Observation | Measured |
|---|---|---|---|
| O-2 | Ground floor, column C-3, north face | Fine vertical hairline cracking over approx. 600 mm above floor level. No spalling, no rust staining, no exposed reinforcement, no displacement across the crack | Below 0.3 mm |

| Ref | Finding | Severity | Action |
|---|---|---|---|
| F-2 | Hairline surface cracking at column C-3, consistent with shrinkage. No section loss, no corrosion, no overload pattern | S1 | None |

**Photo 2** — O-2, column C-3 inspected at close range; hairline surface cracking only. Illustrative photograph.
